PHASE I REPORT
NATIONAL DAM INSPECTION PROGRAM

Name of Dam: LAKE HAMILTON DAM
State & State No.: PENNSYLVANIA, 64-157
County: WAYNE
Stream: FACTORY CREEK
Date of Inspection: May 7, 1980

PHASE I INSPECTION REPORT
NATIONAL DAM INSPECTION PROGRAM

LAKE HAMILTON DAM

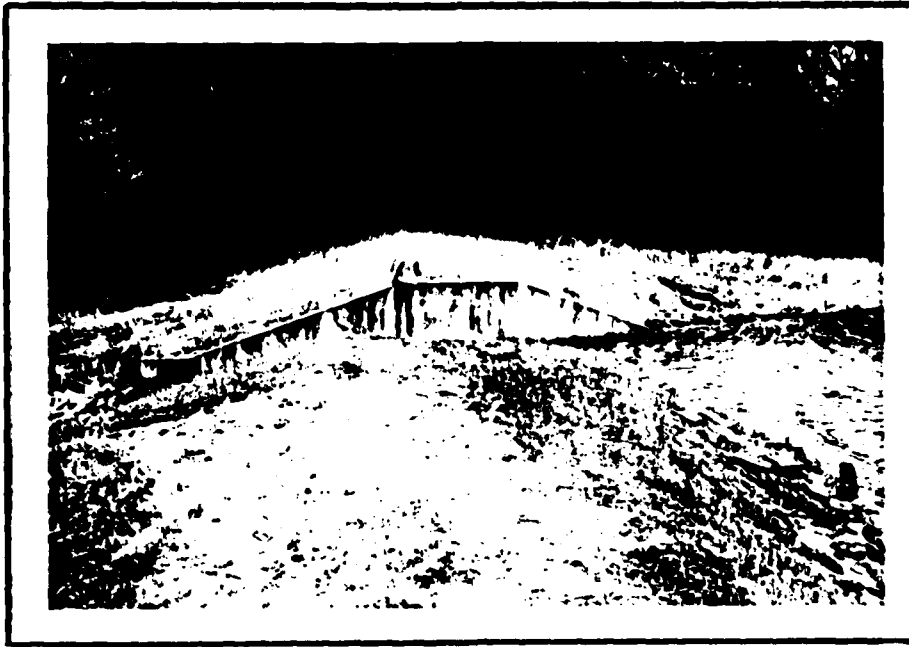
OVERVIEW FROM LEFT ABUTMENT - NO. 2

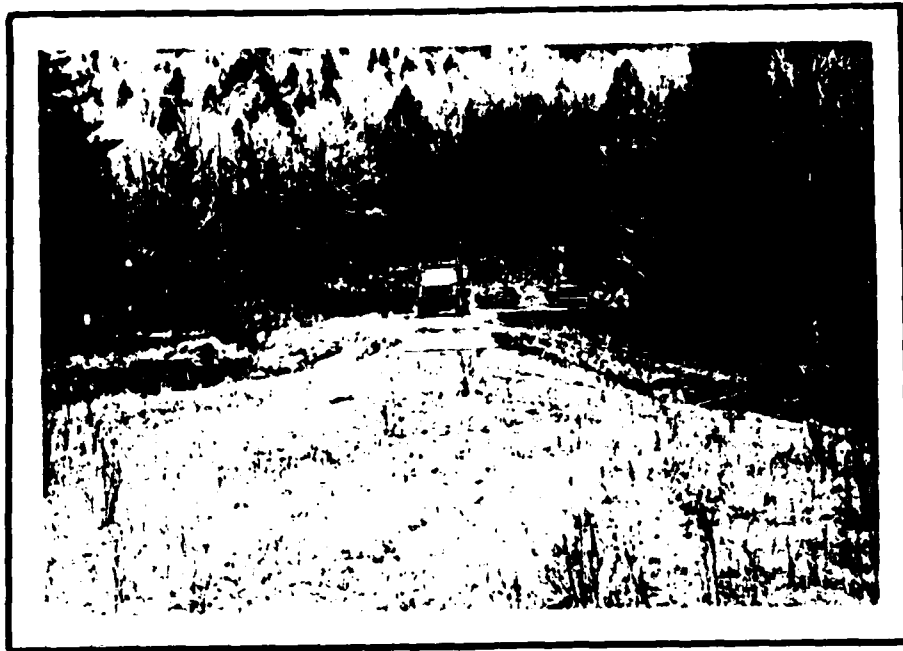
OVERVIEW FROM RIGHT ABUTMENT - NO. 4

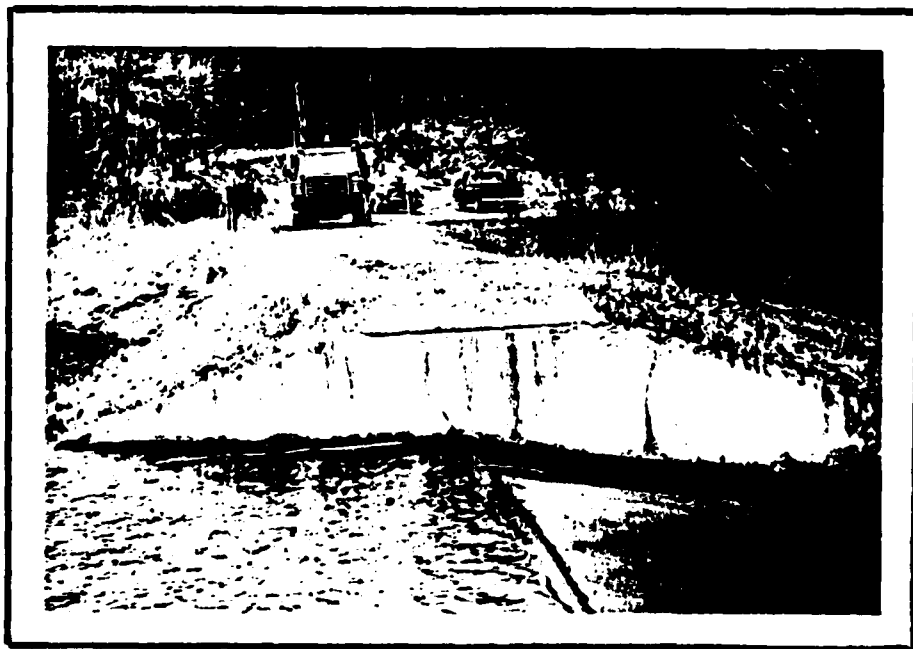
The left spillway wall is deteriorated and has several cracks (Photograph No. 5). The right spillway wall (Photographs No. 6 and No. 7) also has many cracks. A 1/4-inch displacement was noticed at one of the cracks. It is recommended that regular close observations be made of the wall to detect if further movement is occurring.

The spillway weir and slab appear to be in good condition. Heavy riprap has been placed at the downstream side to prevent further erosion. The spillway walls are of some concern due to severe deterioration and cracking. It appears that a quarter inch of movement has occurred in the right wall. Close observation of these walls is required. The observed condition of the walls indicates the need for probable rehabilitation within the next few years.

LEFT SPILLWAY WALL - NO. 5

1. That the spillway walls be closely observed. If further deterioration or wall movement occurs, steps should be taken to replace or repair these walls.
2. That all brush and cuttings be removed from the embankment. Trees within ten feet of the toe should be removed. This area and the embankment should be maintained on a regular basis.
3. That the scarred areas be reseeded to provide an adequate cover against erosion.
4. That additional riprap be placed at the downstream wingwalls to prevent scour.

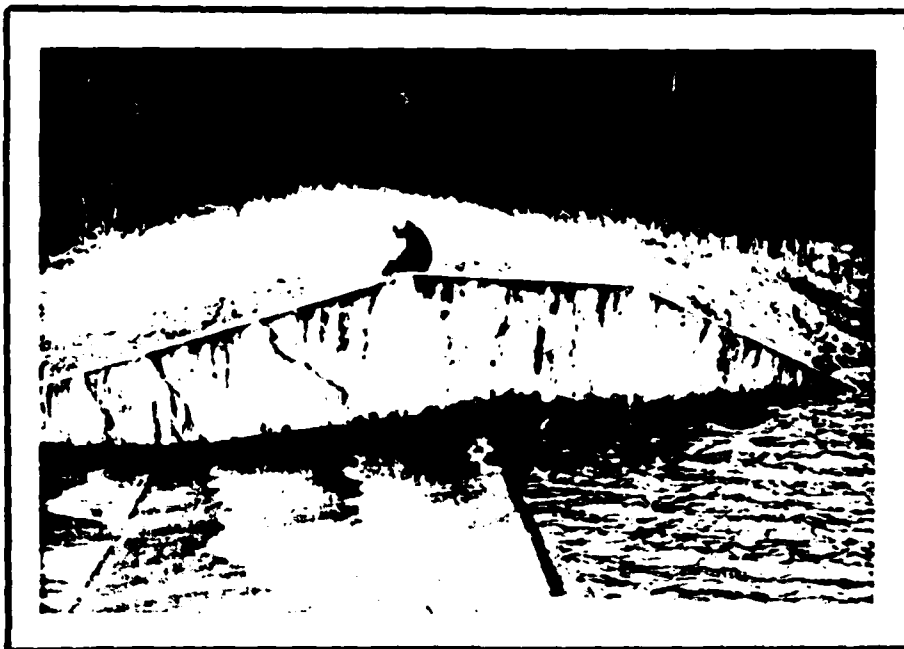
RIGHT SPILLWAY WALL - NO. 6

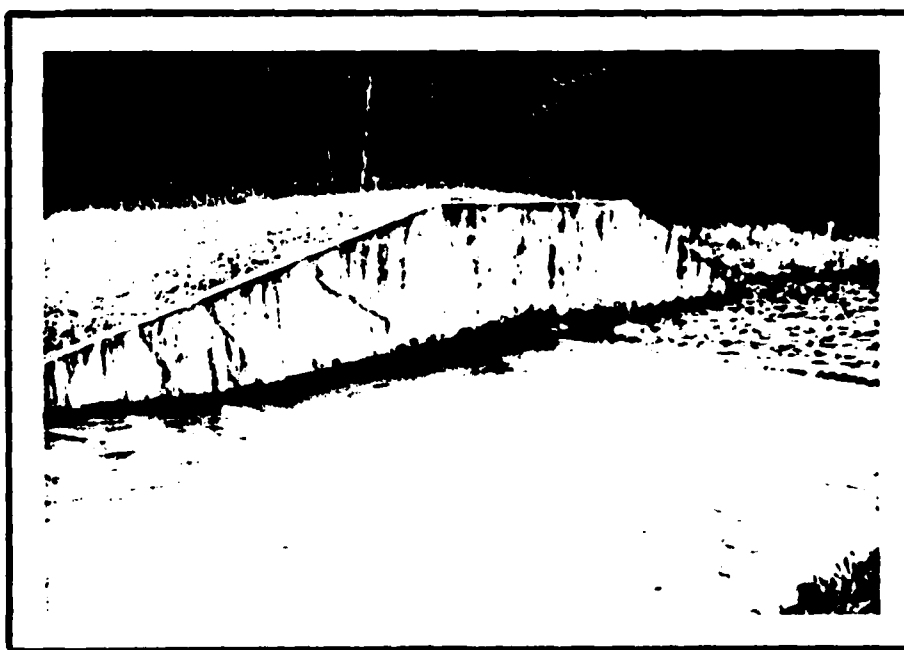
DOWNSTREAM SLAB OF SPILLWAY - NO. 7

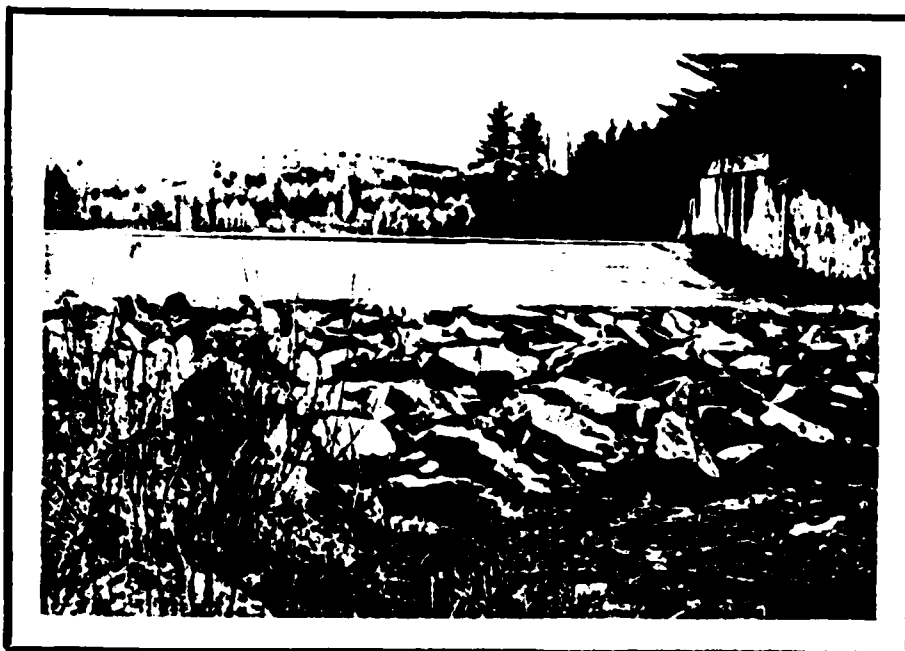
In 1968, the upstream right wingwall was replaced (Plate VI, Appendix E), and in 1979 heavy riprap was placed along the downstream edge of the spillway slab.

RIPRAP PROTECTION AT END OF SPILLWAY SLAB - NO. 8

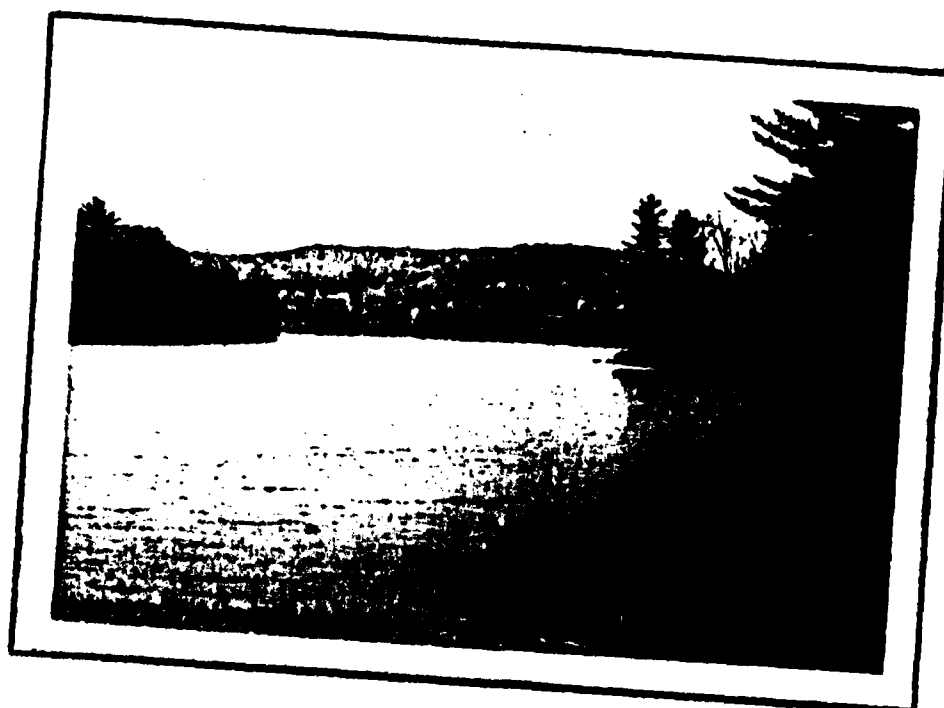
RESERVOIR AREA - NO. 11

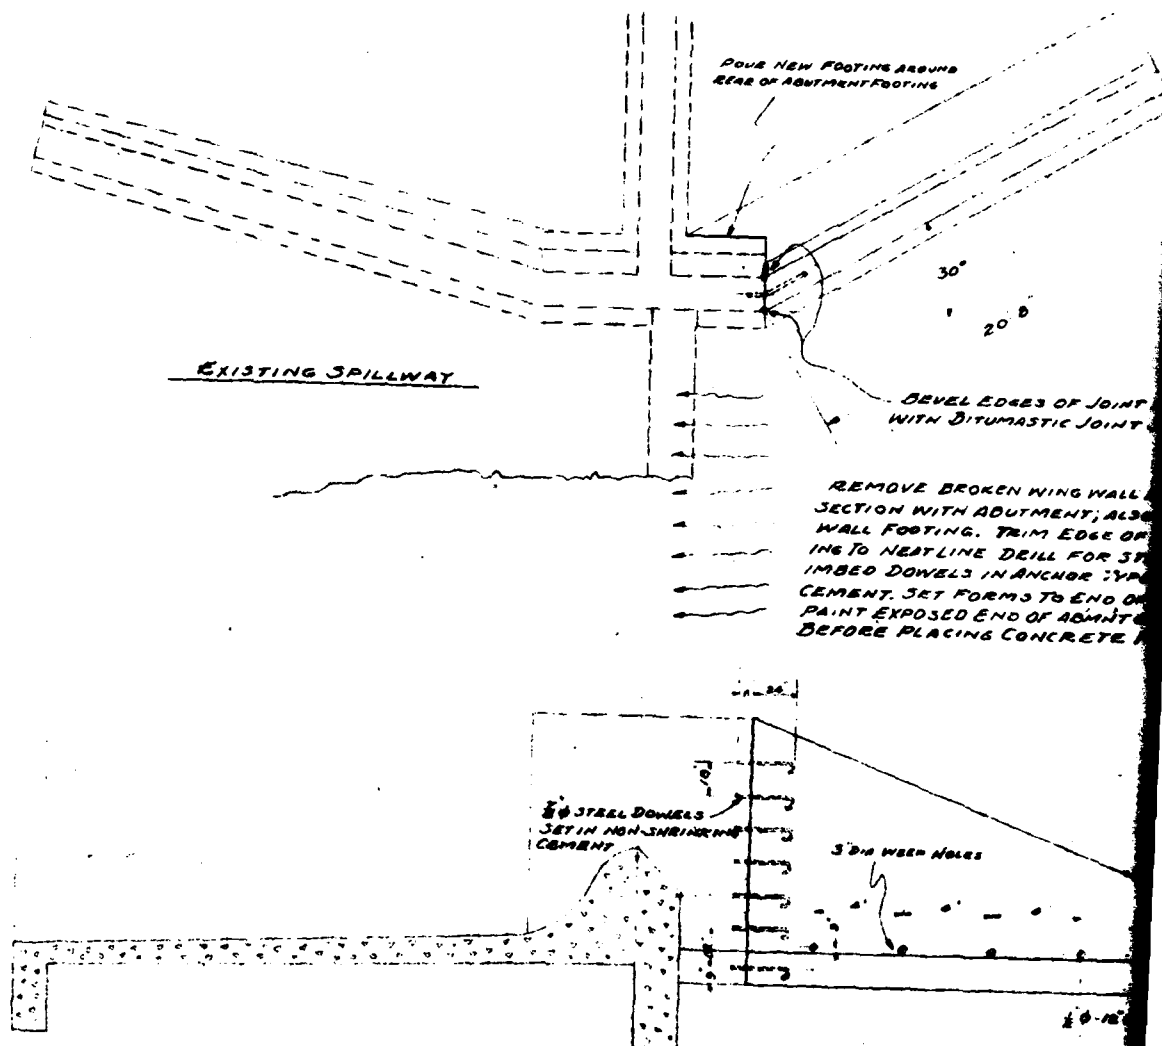
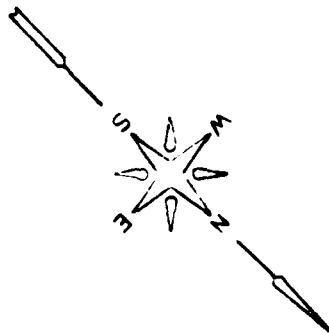
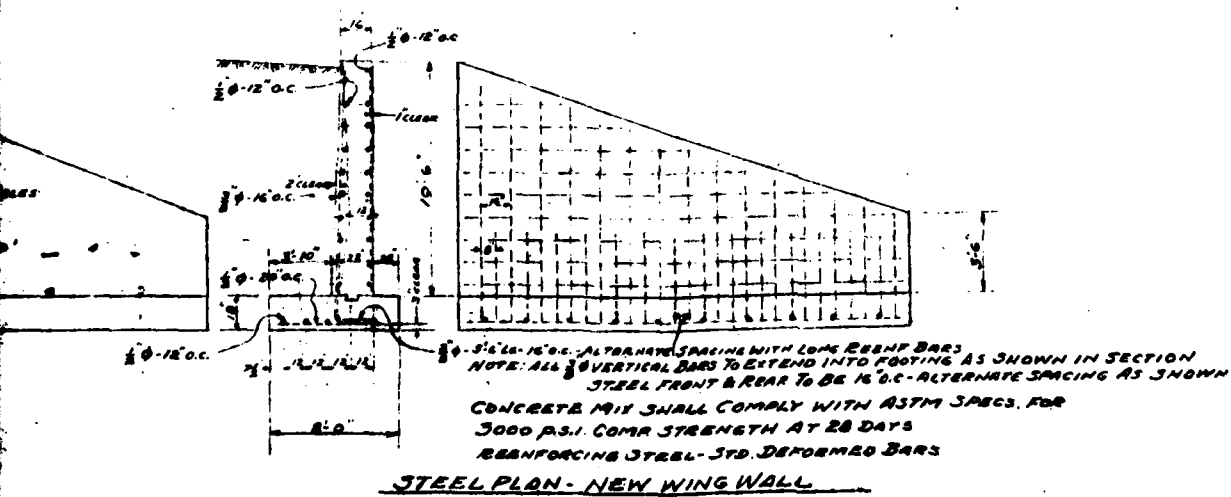
REPAIR TO
WAY-LAKE
MAY 1968

The right forebay wall was replaced with a new wall in 1968 (Plate VI, Appendix E). Although the footing width design appears adequate, cracks have occurred, indicating possible settlement.

BROKEN WING WALL AT POINT OF INTER-
SECTION ABUTMENT; ALSO REMOVE WING
WALL. TRIM EDGE OF ABUTMENT & FOOT-
ING. DRILL FOR STEEL DOWELS AND
INSTALL IN ANCHOR TYPE NON-SHRINKING
CONCRETE TO END OF ABUTMENT.
SEAL END OF ABUTMENT & FOOTING WITH EPOXY RESIN
AND POUR CONCRETE FOR NEW WALL
